Contact Voltage Detection

Midwest Rural Energy Conference
48th Annual Rural Energy Conference
March 11-12
La Crosse, Wisconsin

Chad Hadley, Senior Engineer

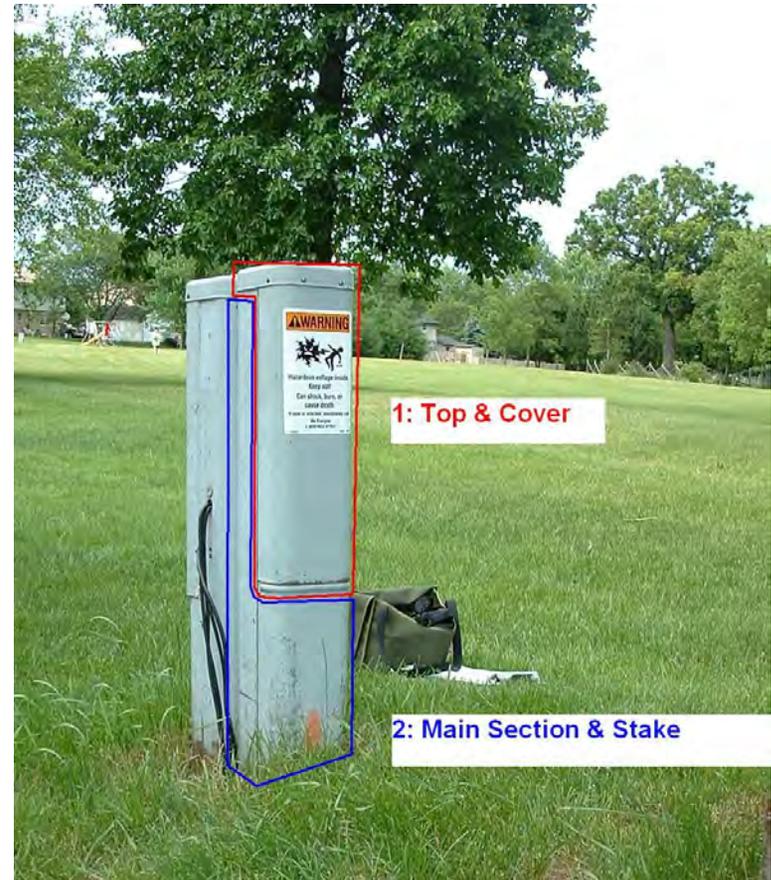
Pedestal Testing

- Cover and base of pedestals not always electrically connected
- Test both sections separately
- Top & cover can have false positives

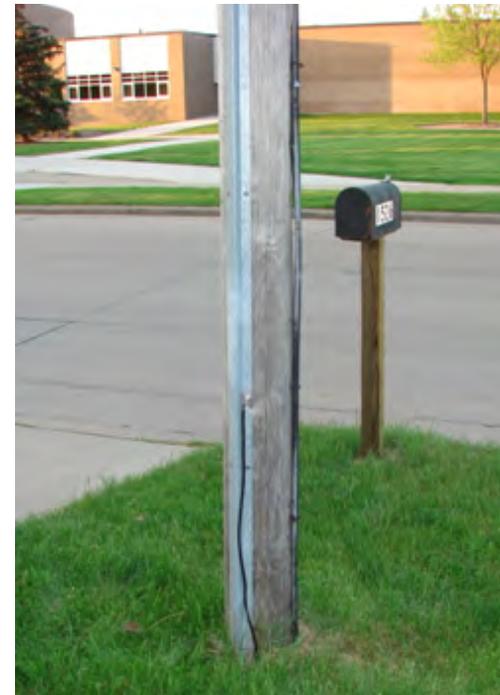
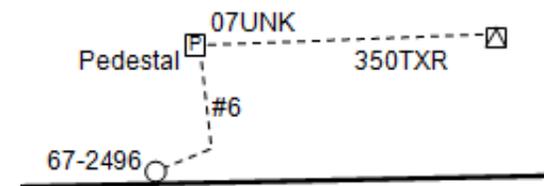
Location #1

- Wood street light pole
- Child received shock from metal u-guard
- U-guard to earth potential was 105 V (1 foot away)
- Neutral conductor that fed the streetlight was connected to the phase connector block at the pedestal
- Cable vintage had poor differentiation between neutral and phase conductor

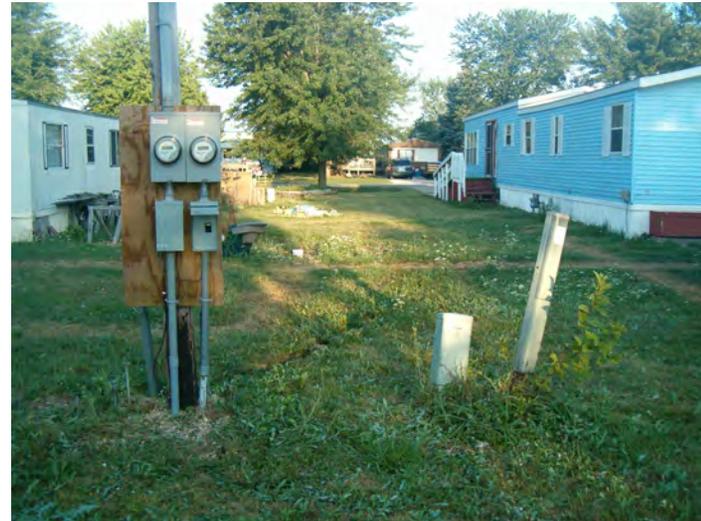
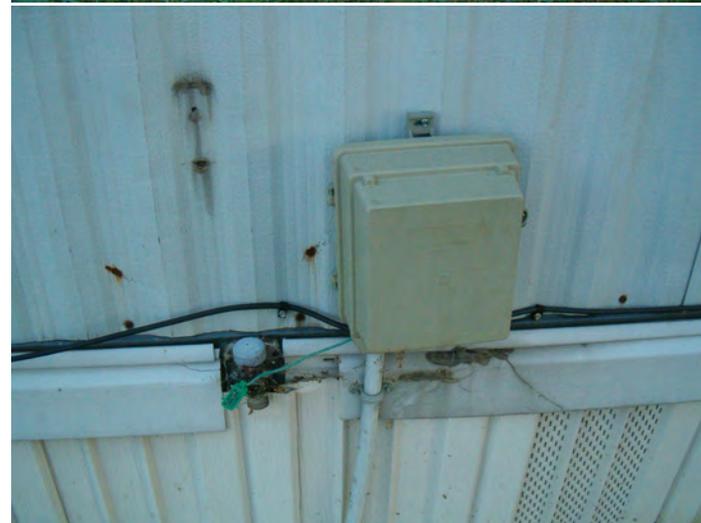
Location #2

- Time Warner pedestal
- Time Warner employee received shock
- Pedestal and Trailer (aluminum) potential to earth was 92 V
- Bad neutral connection within the customer-owned service entrance equipment

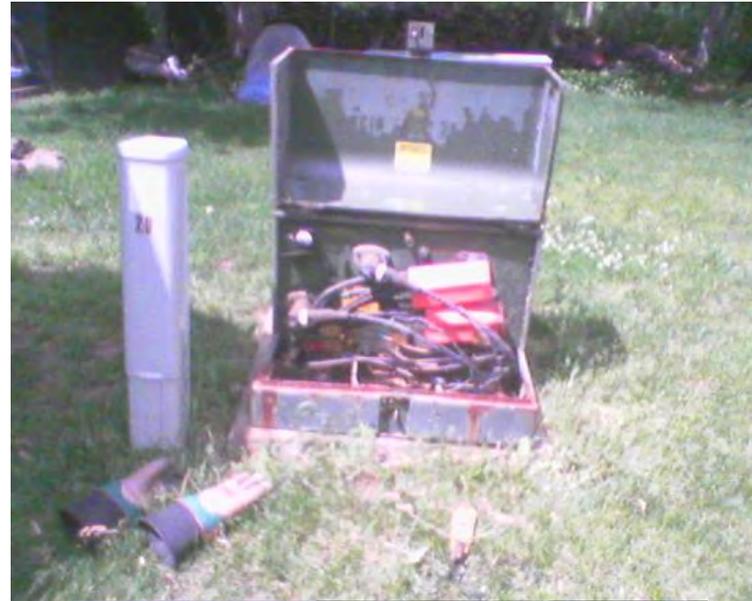
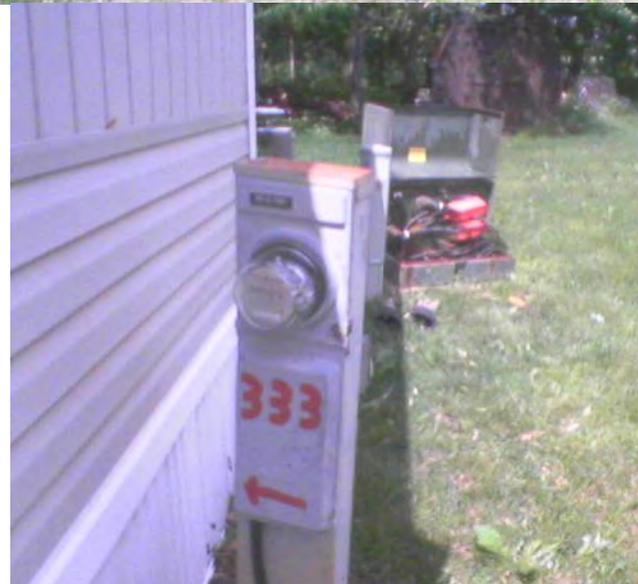
Location #3

- Padmount transformer
 - Potential to earth was 16 V
- Meter Pedestal
 - Potential to earth was 41 V
- Potential cleared when meter was removed
- Cause was due to customer owned equipment
- Electrician was required to make repairs before reconnection

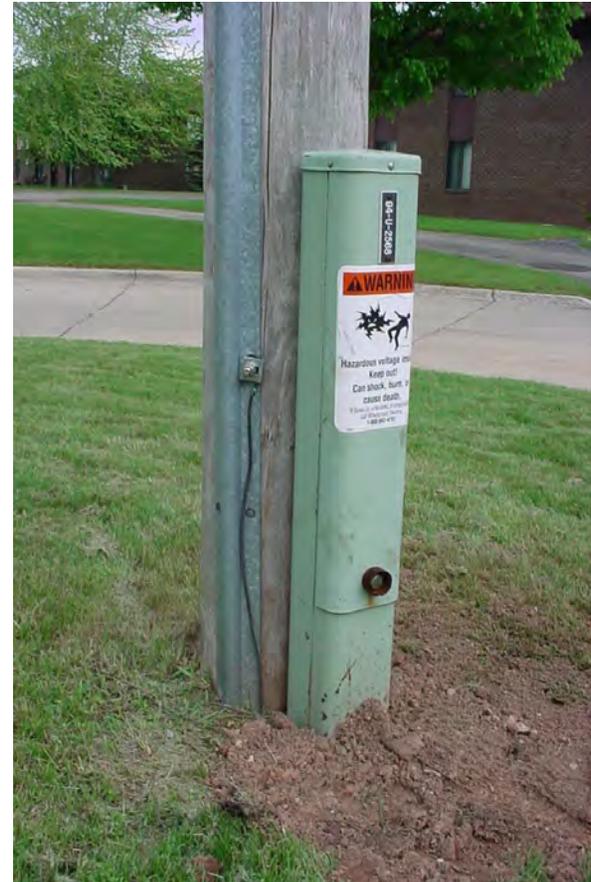
Location #4

- Pedestal feeding 2 streetlights
- Tester signaled 12" away from unit
- Measured 117 Volts between surface of pedestal and earth
- Hot and neutral conductors switched at transformer

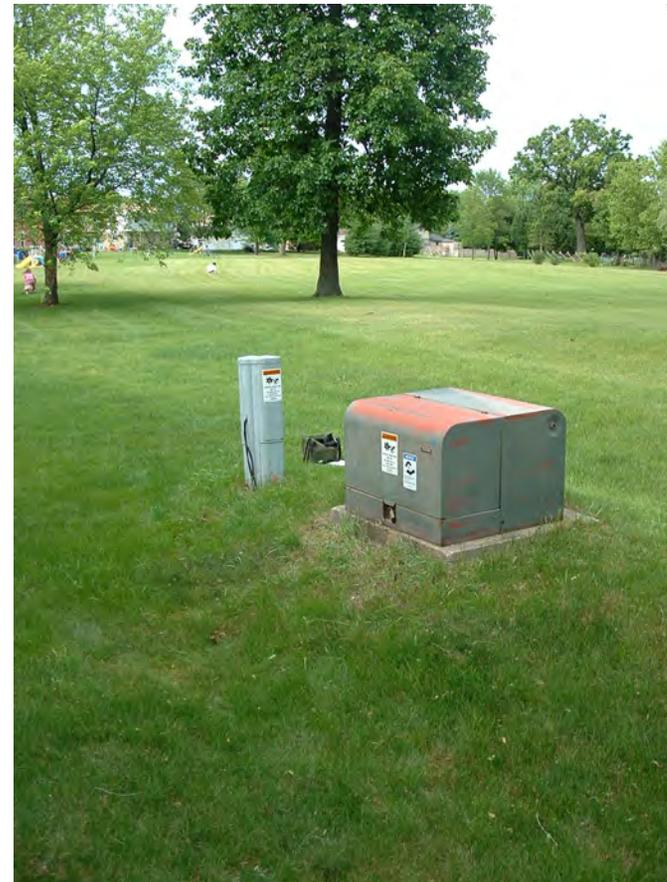
Location #5

- Backyard pedestal
- Tester signaled 6-7" away from front cover
- Measured 117 Volts
- Sharp corner of connector block had worn through the insulating cover

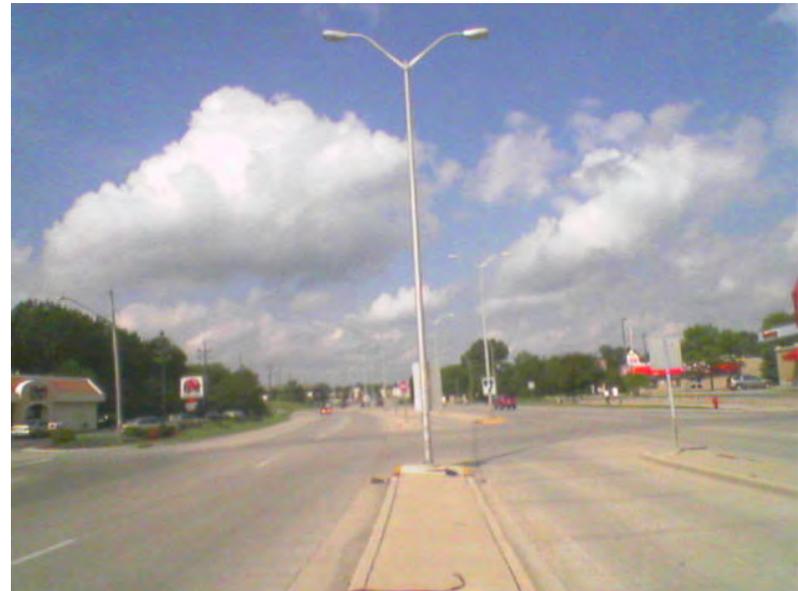
Location #6

- Aluminum street light pole
- Tester signaled 1" away from pole
- Damaged conductor insulation

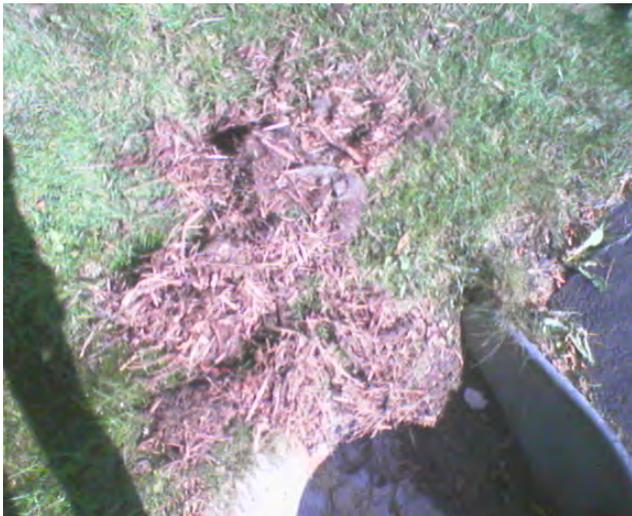
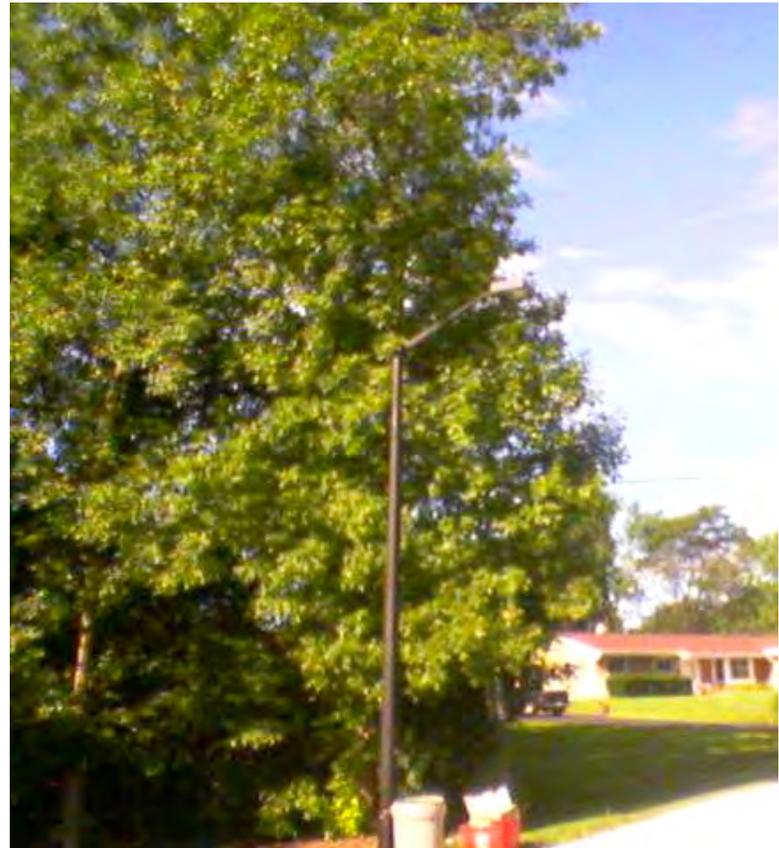
Location #7

- Fiberglass street light pole
- Tester signaled 2" away from pole
- Wires inside had been chewed by a squirrel.

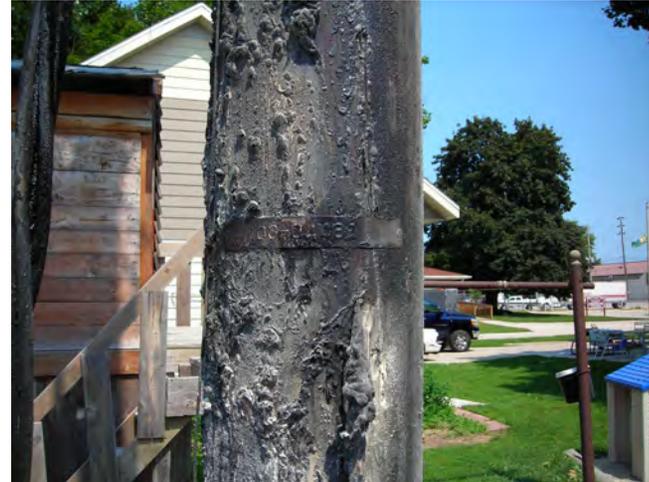
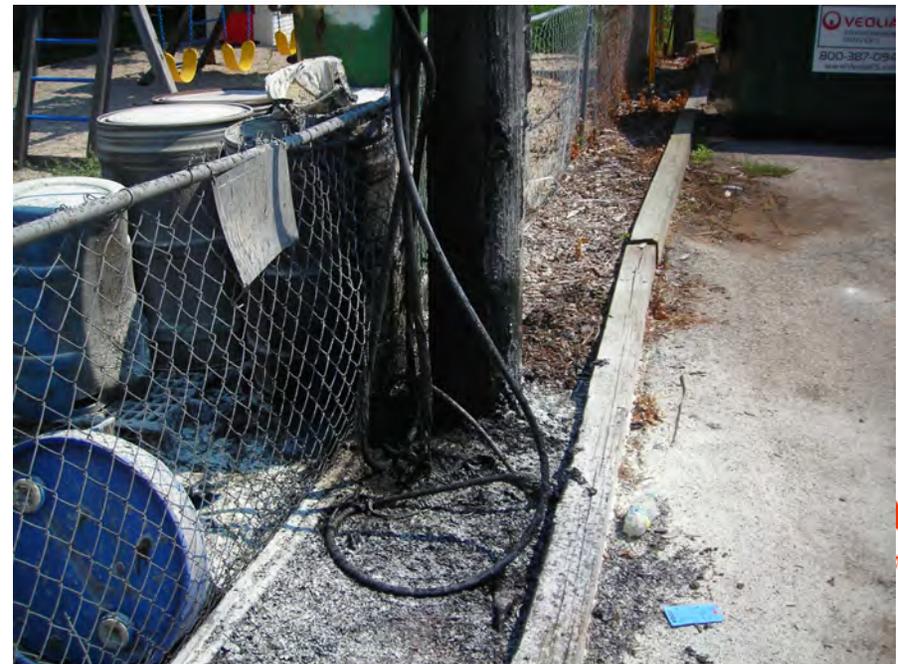
Location #8

- Meat processing plant
- Wood pole fire
- Firefighter received shock from fence
- Fire started 6-12" below ground and melted the plastic u-guard and cable insulation
- Cause by overloaded cables
