Contact Voltage Detection

Midwest Rural Energy Conference
48th Annual Rural Energy Conference
March 11-12
La Crosse, Wisconsin

Chad Hadley, Senior Engineer

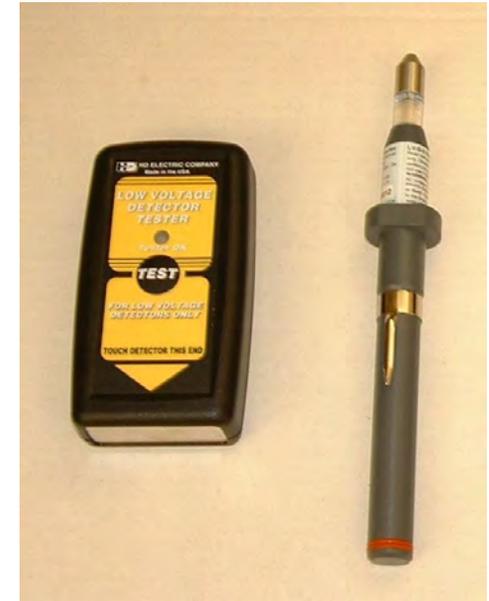
HD Electric tester (LV-S-5)

- Designed for utility use
 - Sensitive down to 5 volts AC
 - (PT-LV-5) AC source for testing
 - Senses 600V at 7"
 - Most sensitive
- Some 'false positives'
 - Non-metallic surfaces (e.g. meter glass, fiberglass poles)
 - Metallic surfaces non-grounded (e.g. metal bolt on a fiberglass pole)
 - Strong electric field from another source (e.g. overhead conductors)

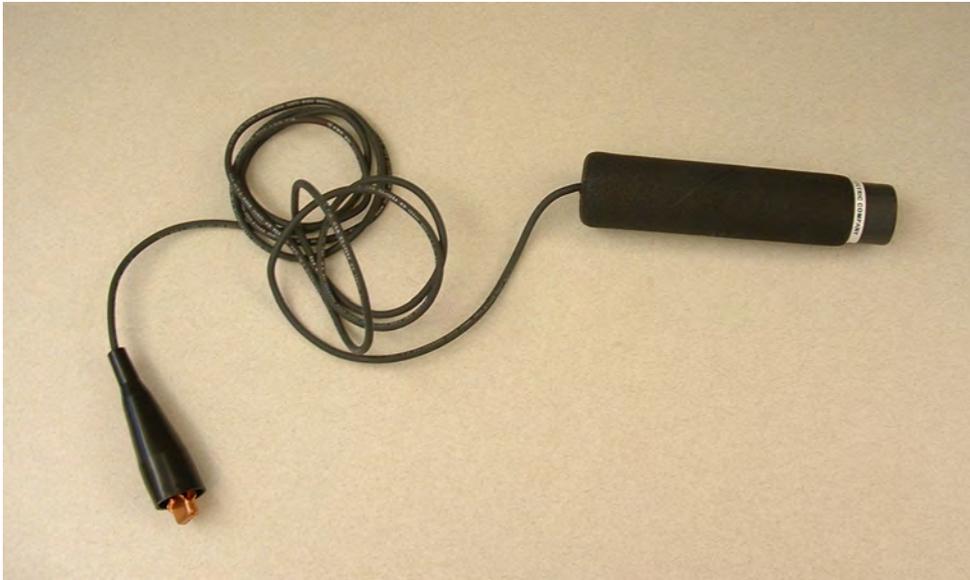
GS-LV

- Ground Shield
- Used with the LV-S-5
- Helps to eliminate the false positives under overhead conductors
- Takes the inspector out of the testing circuit

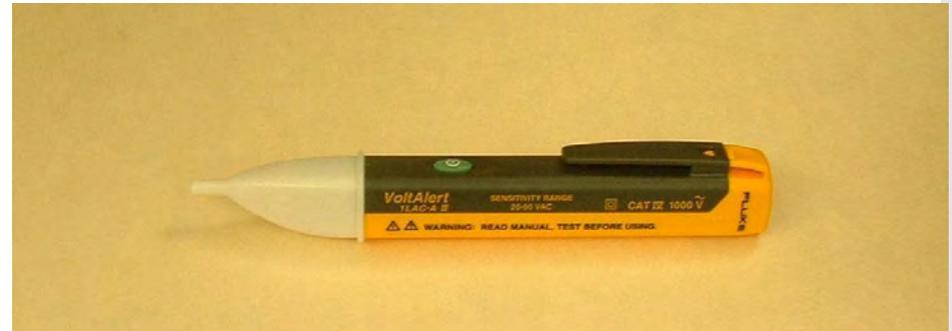
Fluke 1LAC-II

- Similar to LV-S-5
- On/Off feature
- Has audible tone
- Less sensitive than the LV-S-5
- Good results when used for padmount inspections
- False positives similar to the LV-S-5
- Less expensive than LV-S-5

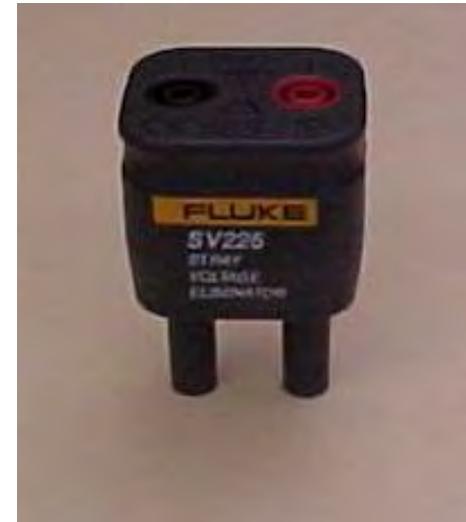
Fluke SV225

- Used with a digital multimeter (Fluke 87A)
- Shunt resistor (3.3K Ohm)
- Used to differentiate between high impedance and low impedance voltage sources
- Used only after testing without a resistor
- Simulates an animal or human load coming in contact with the voltage
- Note: Auto scaling voltmeters may switch to millivolts

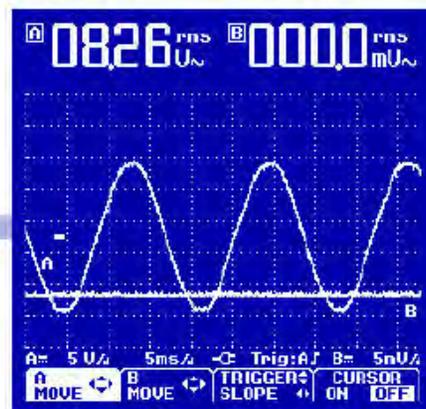
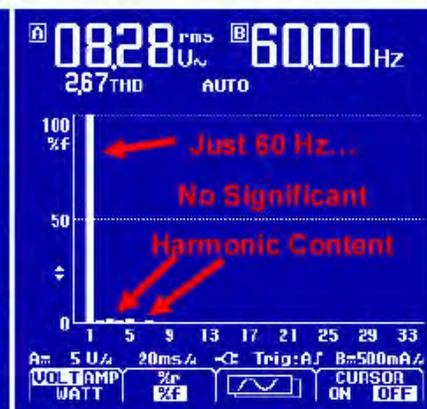
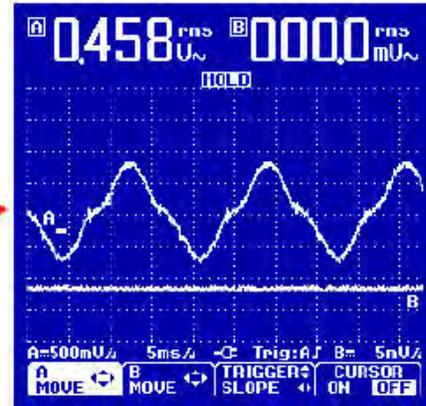
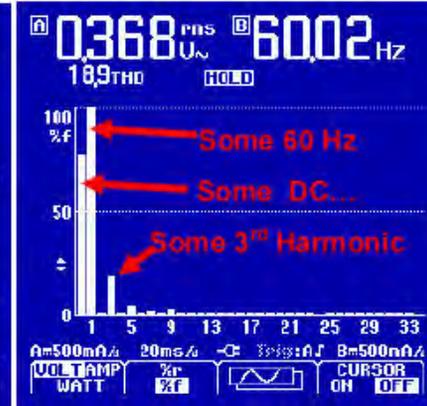
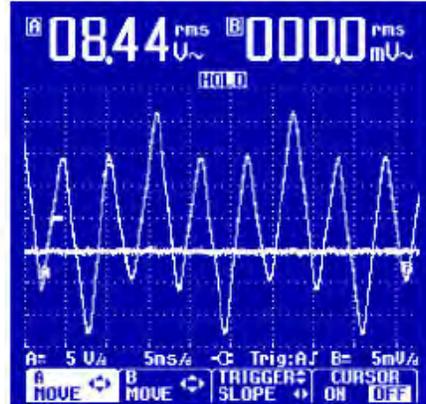
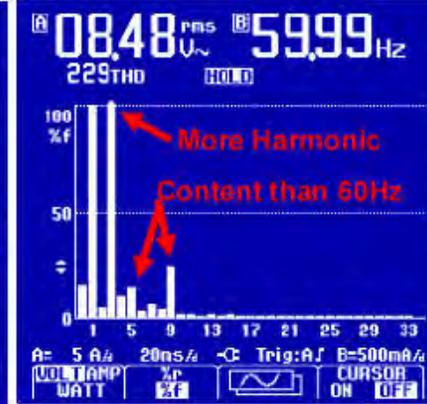
ScopeMeter Waveform Analysis Helps with Source Identification

- 60 Hz Faulted Phase Conductor (Source path Issue)
- Higher Harmonic Content Neutral to Earth Voltage (return path issue)
- Voltage Snapshot Gas Pipeline to Remote Earth (high % return path issue)
